44TH TURBOMACHINERY & 31ST PUMP SYMPOSIA
HOUSTON, TEXAS | SEPTEMBER 14 – 17 2015
GEORGE R. BROWN CONVENTION CENTER

Fit For Purpose Unique Machinery Repair Techniques for Late in Life Production Facilities

Case Study 1 – Eroded Compressor Diaphragm

Case Study 2 – Bent High Speed Gear Rotor

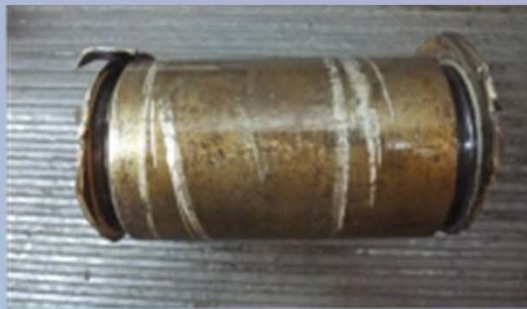
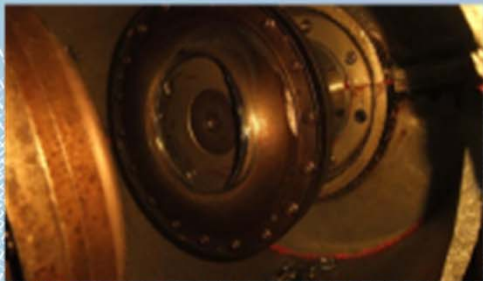
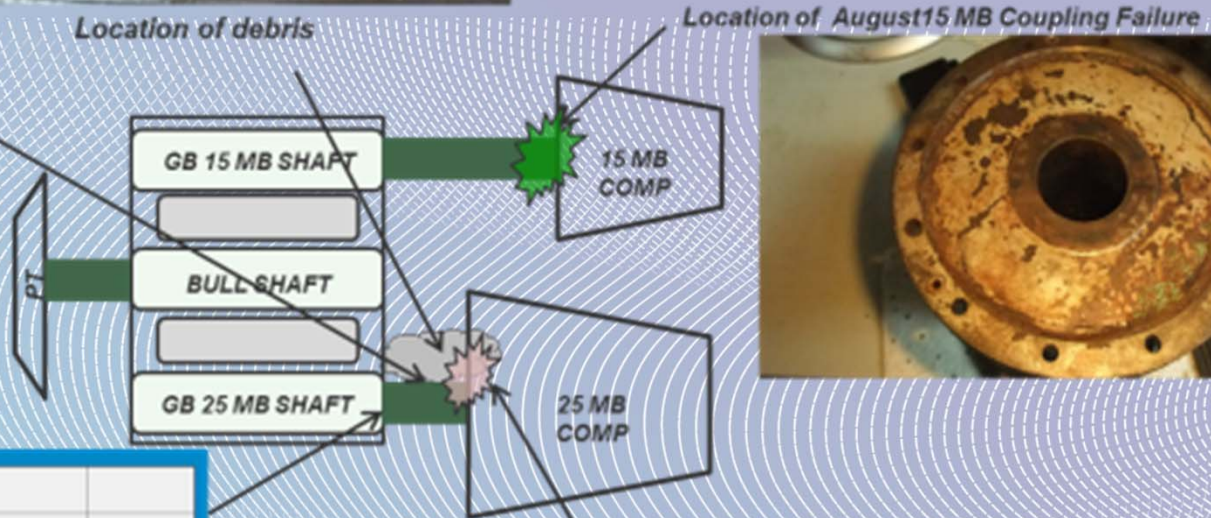
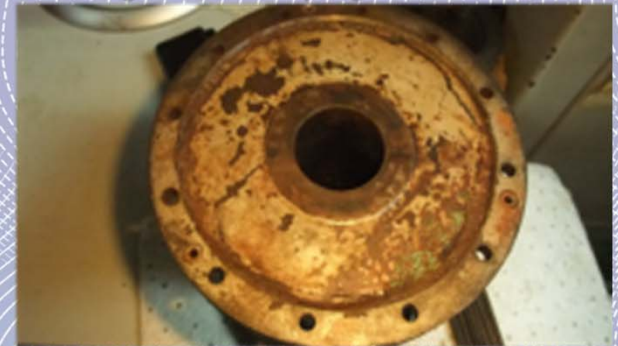
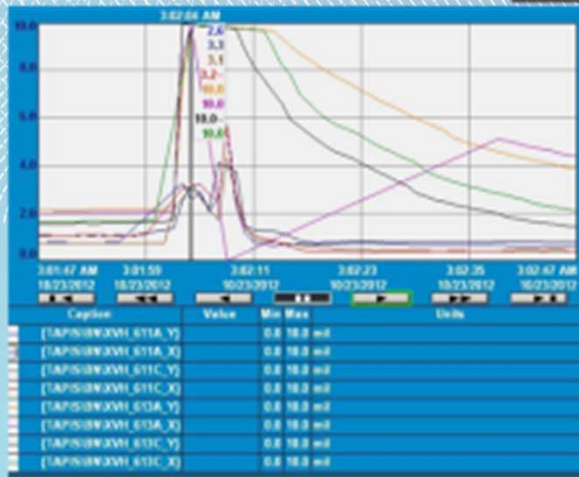
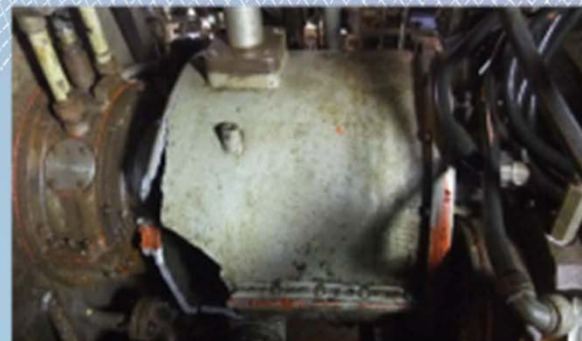
High Speed Gear Rotor Set Overview

- 5 rotors: 1 input, 2 output and 2 intermediate shafts
- Input Shaft is driven by the PT and is the only shaft with a thrust bearing (gear double helical design)
- Speed Ratio is the same on both output shafts (1.489)
- Output Shaft 1 Drives a larger Low Pressure Compressor
- Output Shaft 2 Drives a Smaller High Pressure Compressor
- Operating speed for either Output Shaft is approximately 11,000 rpm

- First coupling failure (Train A) led to bent output shaft 1 driving Low Pressure Compressor Coupling
- Second coupling failure (Train B) led to bent output shaft 2 driving High Pressure Compressor Coupling
